Manhole Inspection Summary

Manhole # S21I__026MH

Insp Date: **9/20/07 2:54 PM**

Location Address: **1800 HOLLINS ST**

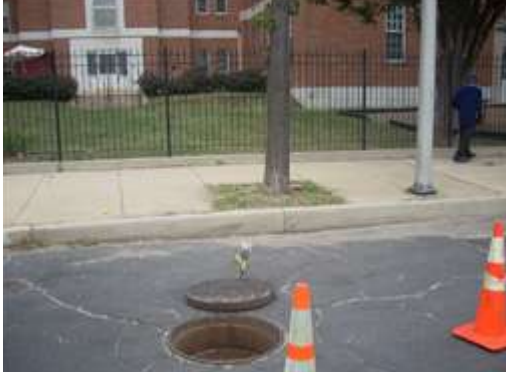
Location View

DEBRIS ON BENCH

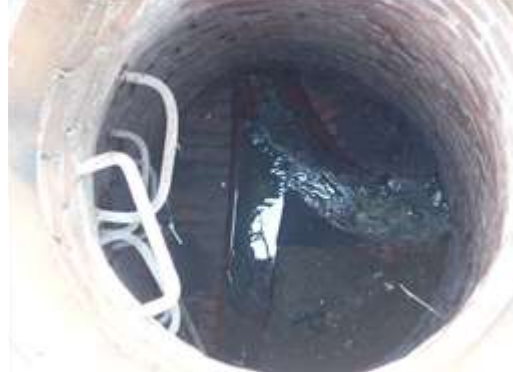
Top View

Condition: ☐ Sound ☐ Cracked ☐ Root Intrusion ☐ Deteriorated ☐ Leaks ☒ **Debris**

A LOT OF DEBRIS IN I3 CHANNEL

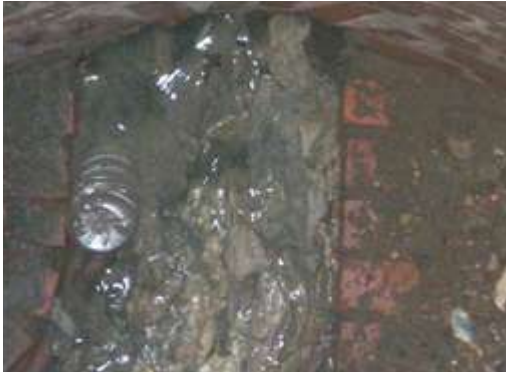
Defect 1

A LOT OF DEBRIS IN I3 CHANNEL

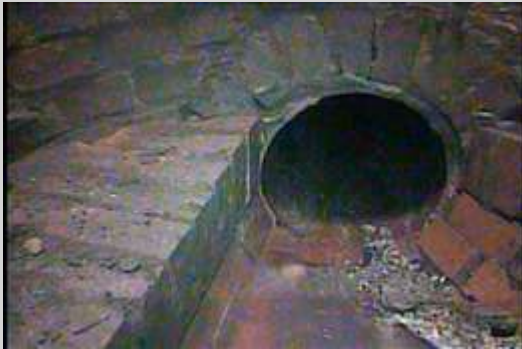
12 O'Clock Outflow

DEBRIS ON BENCH

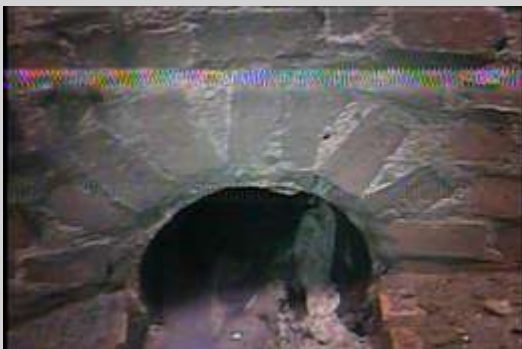
3 O'Clock Inflow

A LOT OF DEBRIS IN I3 CHANNEL

Pipe Height: **10.8** (in.) Rod and Bar (Angled)
Pipe Material: **Clay** ☐ Pipe Lined
Invert Depth: **9.96** (ft.) Flow Characteristics: **Slow**
Deposits: ☐ None ☐ Mud ☐ Sludge ☒ **Debris** ☐ Grease
Silt Depth: **5** (in.) Deposits Extent: **Heavy**
Infiltration: **None** Pipe Seal Cond: **Sound**

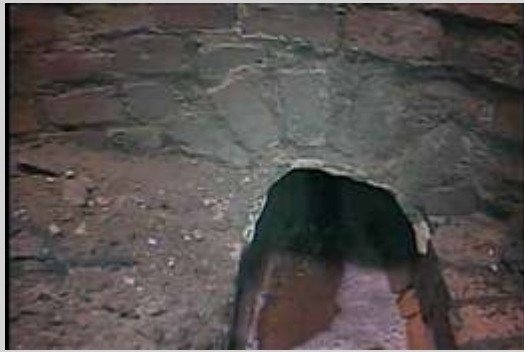
7 O'Clock Inflow

DEBRIS ON BENCH

Infiltration: **None** Pipe Seal Cond: **Broken**
